USING SOIL ADJUSTED VEGETATION INDEX TO ASSESS LAND DEGRADATION ALONG SECTIONS OF MUTONGA RIVER CANYON

Kinoti, D.K.

Department of Arts and Humanities, Chuka University, P. O. Box 109-60400, Chuka

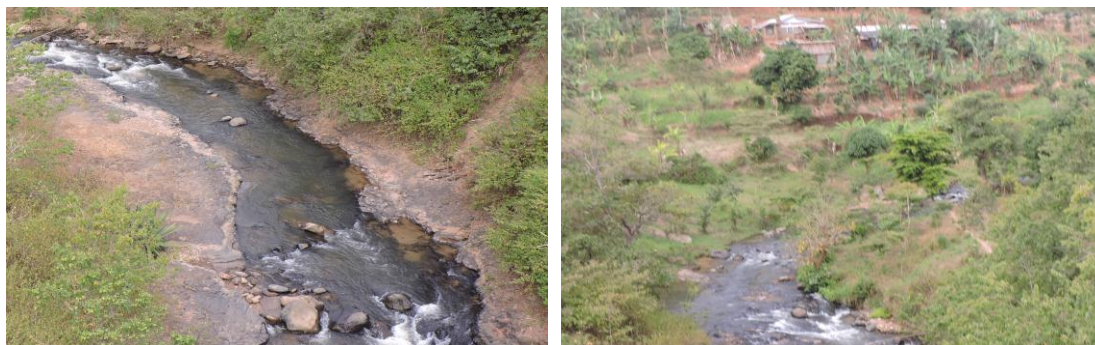
Plates 1&2: Section of Mutonga River along the Canyon

Land degradation is an increasing global environmental challenge especially in developing countries. Due to reliance on environmental goods for livelihood, land degradation is common in high potential as well as arid and semi-arid lands of Kenya. It is common that most people continue to be exposed to environmental conditions that can adversely expose them to health problems. In this study land degradation is the removal of vegetation or any cover on the earth's surface. Bare land is one of the most important and typical land covers all over the world (Hui et al, 2017). Quarry and related activities have been singled as human endeavours irreversibly impacting on the canyon's slope instability, water quality and riverine vegetation loss. Mutonga River originates from the eastern slopes of Mt. Kenya and flows downstream (Plate 1)

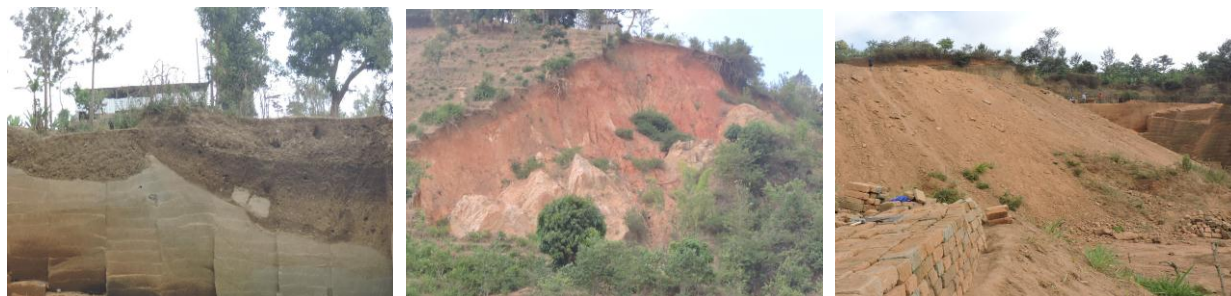
Plates 3, 4 and 5: Encroachment on Canyon's escarpment, vegetation and settlements

important Kaolinitic quarry site with over 60 percent of supplied quarry building stones within Meru and Tharaka-Nithi counties sourced from the canyon. Increased stone mining has been witnessed in this area with the entry of local and international stone machine quarry companies. Notably, the introduction of stone dressing machines has brought competition to the traditional quarries. Dense concentration of stone quarrying related activities has encroached on the escarpments, riverine vegetation and natural lands along the stretch (Plate1&2). Conversion of natural land into loose surface may have negative impacts on riverine ecosystem and related hydrological characteristics. Reported impacts of geomorphic failure have in the recent past resulted to fatal landslides claiming the life of quarry workers. Land degradation is now common along this stretch due to excavation and dumping of quarry wastes.

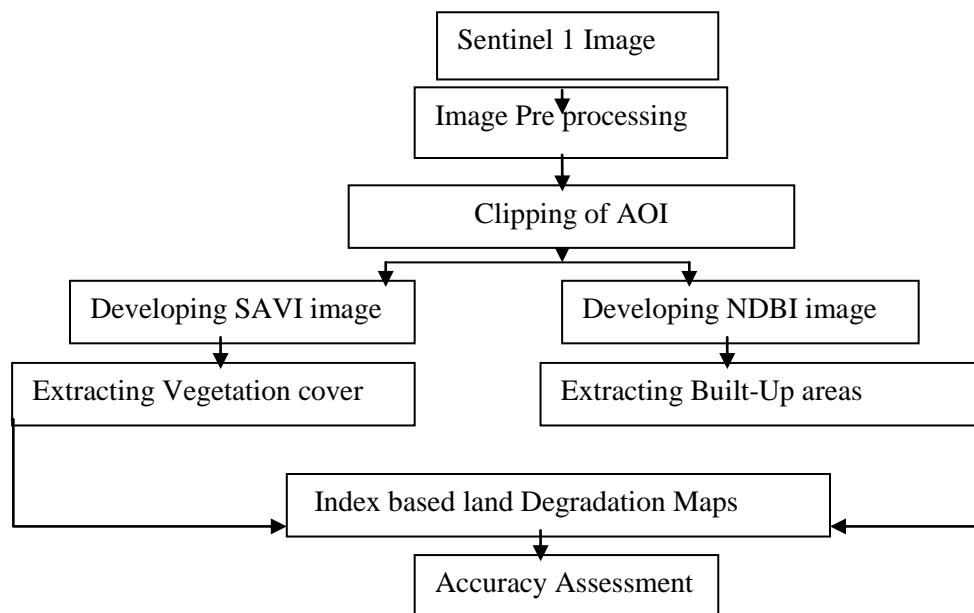
Figure 3: Schema used in assessing land degradation from image data

To quantify the spatial extent of exposed bare land, the study applied SAVI and normalised difference built-up index (NDBI) results comparatively. The study area's changes introduced by the increased human activities can best be analysed using specialised indices.
